# AN ATR INVESTIGATION OF COATINGS ON GLASS

This application note explores the possibility of examining these types of coatings on glass using FTIR single reflection diamond ATR.

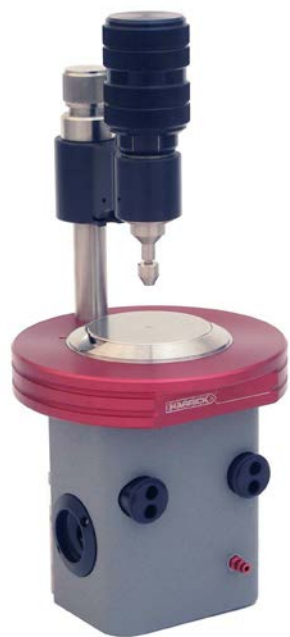
Figure 1. The [DiaMaxATR](#).

Spectra were obtained on a FTIR spectrometer equipped with the DiaMaxATR™ high throughput diamond ATR. Five samples were examined: fresh soda lime silica glass, corroded silica glass and three coated glasses. The samples were pressed against the ATR crystal using the maximum force allowed by the pressure applicator. Spectra were collected relative to the clean ATR crystal, from 4000 to 650

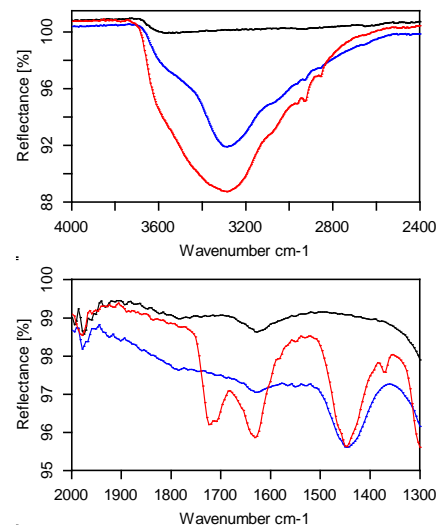
Figure 3. The ATR spectra of three coated glasses (red, blue and green) compared to fresh glass (black).

Figure 3 shows the spectra of two coated soda lime silica glass samples in comparison to the fresh glass. The two coated samples have a much richer structure in the OH stretching region than either the fresh silica or corroded silica, indicating that the OH is bound in a variety of

different ways to the surface<sup>1</sup>. The bands in the 1500-2200  $\text{cm}^{-1}$  region are generally attributed to the Si-O-H...O-Si stretches and bends<sup>2</sup>. The differences are likely due to various inorganic additives in the coatings which shift the bands and change their intensities.
