ANALYSIS OF WEAR SCRATCHES ON METAL SURFACES USING DIAMOND ATR

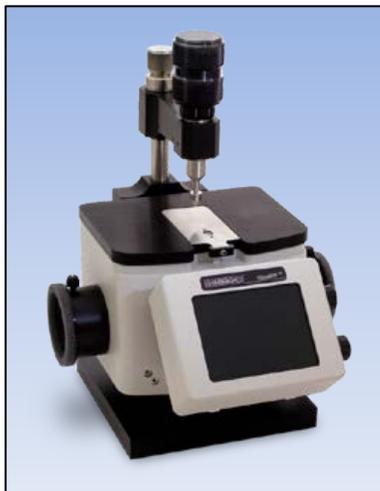
Figure 1. Samples 1 and 2 from left to right.

The samples investigated were polished steel discs, 28 mm in diameter by 8 mm thick and defects thereon (see Figure 1). Sample 2, the darker sample, has a carbon based coating on top to enhance the surface hardness. The three samples were lubricated, tested and then cleaned with n-heptane, leaving chemisorbed species in the wear scratches on the surface.

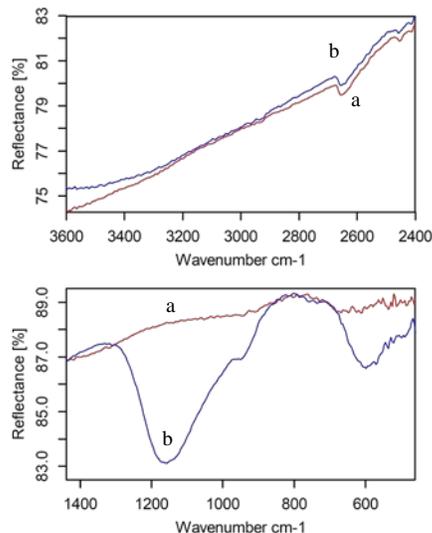
- a. Photograph of an area on sample 1 area with minimal wear. Shown in red in the spectra below.

- b. Photograph of a scratched section of sample 1. Shown in blue in the spectra below.

Figure 3. Photographs and ATR Spectra of Sample 1.

Figures 3 and 4 show spectra measured from a section with wear scratches in comparison to a shiny smooth section, along with photographs of the areas of each sample that were examined. The worn areas of sample 1 show slightly more intense bands in the 2800-3000 cm^{-1} region relative to the shiny areas. This indicates that an organic residue or chemisorbed species remained in the worn area. The wear scratches in both of these samples have distinct bands at 1174 cm^{-1} , 956 cm^{-1} and 609 cm^{-1} , so it is likely both have worn in a similar fashion or were lubricated with the same material.

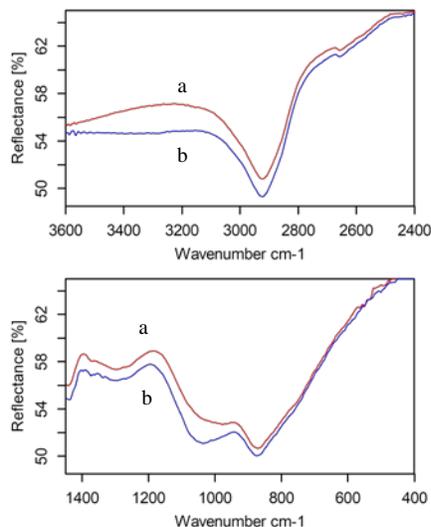
- a. Photograph of an area on sample 2 area with minimal wear. Shown in red in the spectra below.

- b. Photograph of a scratched section of sample 2. Shown in blue in the spectra below.

Figure 4. Photographs and ATR Spectra of Sample 2.

The spectrum of a relatedly unworn section of sample 2 is distinctly different from that of samples 1. This is either due to the carbon-based coating on it or the interaction of the coating with the lubricant. The wear scratches show additional changes in the infrared spectrum at 3320 cm^{-1} and 1045 cm^{-1} .

Note that the change in band intensities for the wear scratches is much smaller for the sample with the carbon-like coating, indicating that the coating is protecting the component from wear.
