Analysis of Wear Scratches on Metal Surfaces Using Diamond ATR

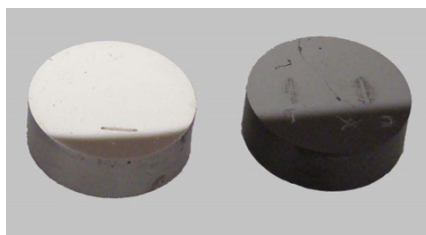
Figure 1. Samples 1 and 2 from left to right.

The samples investigated were polished steel discs, 28 mm in diameter by 8 mm thick and defects thereon (see Figure 1). Sample 2, the darker sample, has a carbon based coating on top to enhance the surface hardness. The three samples were lubricated, tested and then cleaned with n-heptane, leaving chemisorbed species in the wear scratches on the surface.

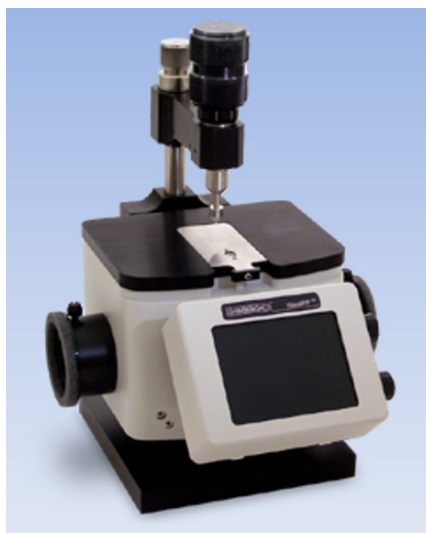
Figure 2. The VideoMVP diamond ATR accessory.

The spectra of the discs were measured on a FTIR spectrometer equipped with the Harrick [VideoMVP™](#) (see Figure 2) with its optional Force Sensor. The background spectrum was collected from the clean ATR crystal. Then the sample was placed, face down, on the diamond crystal and positioned over the area of interest using the image on the display. The pressure applicator was lowered to apply ~240N of force to compress the sample against the crystal. The spectrum and image were then recorded. All spectra were collected from 4000 to 400 cm^{-1} using 32 scans at 8 cm^{-1} resolution.

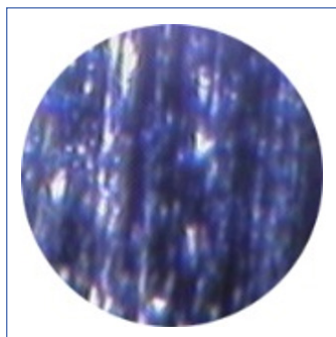
b. Photograph of a scratched section of sample 1. Shown in blue in the spectra below.

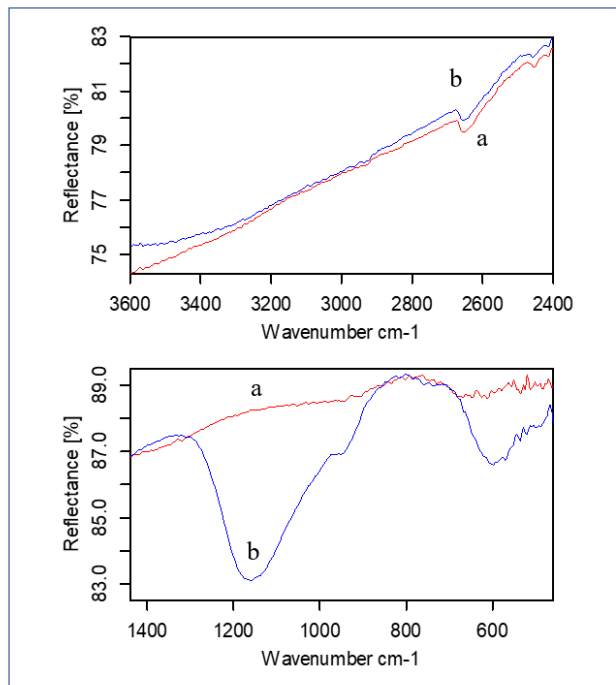
Figure 3. Photographs and ATR Spectra of Sample 1.

Figures 3 and 4 show spectra measured from a section with wear scratches in comparison to a shiny smooth section, along with photographs of the areas of each sample that were examined. The worn areas of sample 1 show slightly more intense bands in the 2800-3000 cm^{-1} region relative to the shiny areas. This indicates that an organic residue or chemisorbed species remained in the worn area. The wear scratches in both of these samples have distinct bands at 1174 cm^{-1} , 956 cm^{-1} and 609 cm^{-1} , so it is likely both have worn in a similar fashion or were lubricated with the same material.

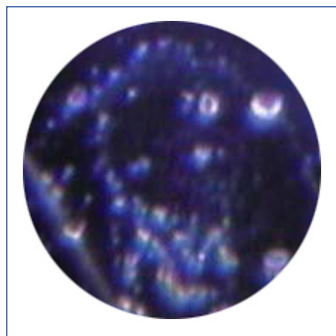
b. Photograph of a scratched section of sample 2. Shown in blue in the spectra below.

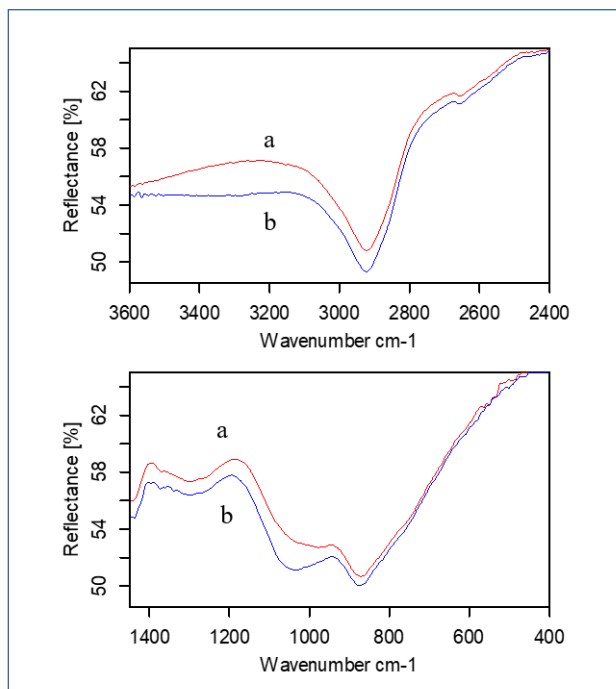
Figure 4. Photographs and ATR Spectra of Sample 2.

The spectrum of a relatedly unworn section of sample 2 is distinctly different from that of samples 1. This is either due to the carbon-based coating on it or the interaction of the coating with the lubricant. The wear scratches show additional changes in the infrared spectrum at 3320 cm^{-1} and 1045 cm^{-1} .

Note that the change in band intensities for the wear scratches is much smaller for the sample with the carbon-like coating, indicating that the coating is protecting the component from wear.
