AN ATR INVESTIGATION OF COATINGS ON GLASS

This applications note explores the possibility of examining these types of coatings on glass using FTIR single reflection diamond ATR.

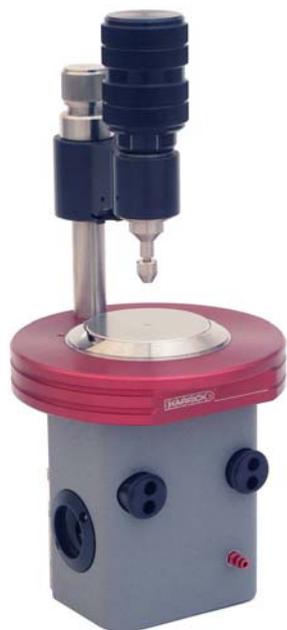
Figure 1. The DiaMaxATR.

Spectra were obtained on a FTIR spectrometer equipped with the DiaMaxATR™ high throughput diamond ATR. Five samples were examined: fresh soda lime silica glass, corroded silica glass and three coated glasses. The samples were pressed against the ATR crystal using the maximum force allowed by the pressure applicator. Spectra were collected relative to the clean ATR crystal, from 4000 to 650
